Asbestos Audit (Division 6) of First Floor, 22 Little Chapel Street, Prahran Vic

September 2020

Prepared for: City of Stonnington
PO Box 21
Prahran, VIC 3181

Job Number: 9439

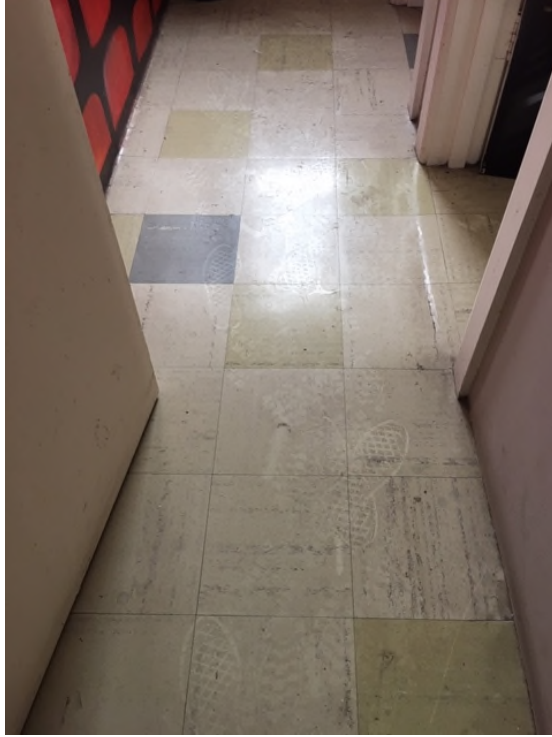
Photograph 1: Toilet – Asbestos vinyl floor tiles

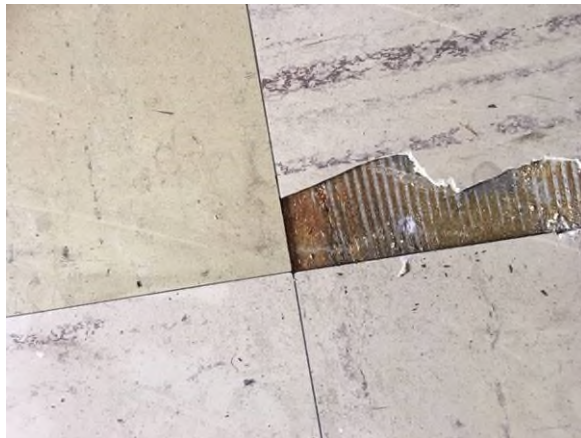
Photograph 2: Kitchen- Asbestos vinyl floor tiles

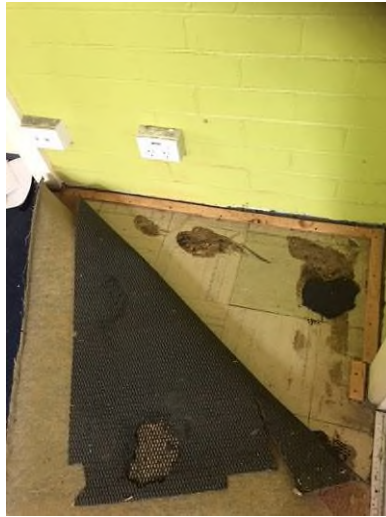
Photograph 3: Stairs/Foyer- Asbestos vinyl floor tiles below carpet

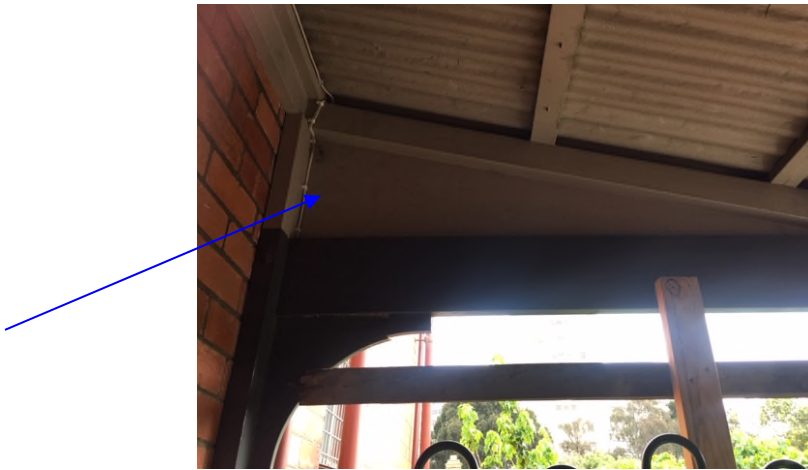
Photograph 4: External- Asbestos cement sheeting

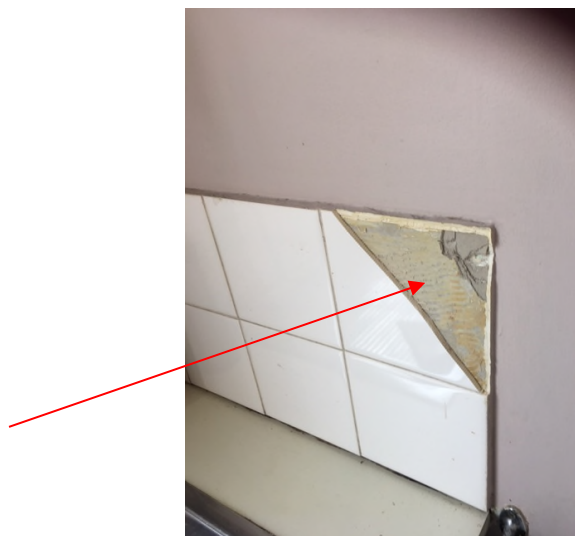
Photograph 5: Kitchen- Non-Asbestos cement sheeting behind tiles

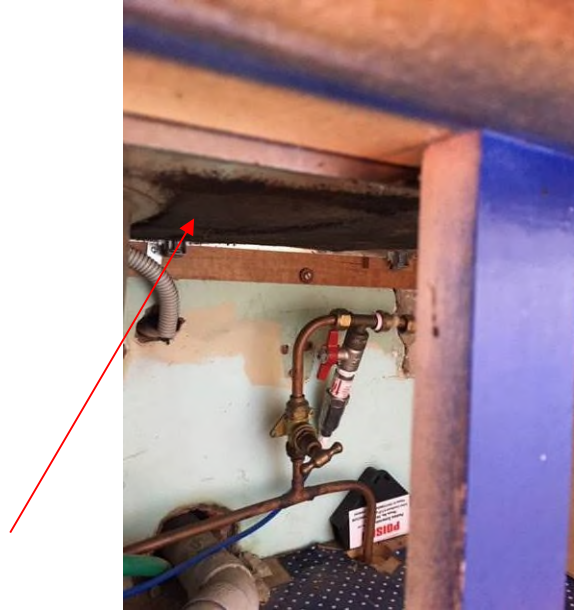
Photograph 6: Kitchen- Non- Asbestos coating below sink

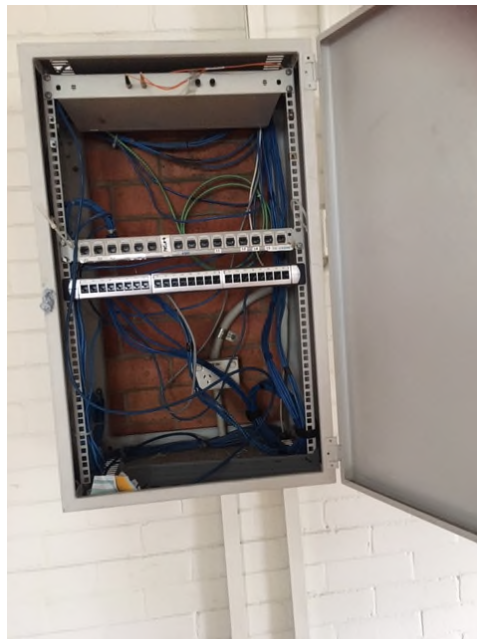
Photograph 7: Open space- No electrical switchboard noted in cupboard
